PASSAMAQUODDY TIDAL POWER DEVELOPMENT
FINAL REPORT
OCTOBER 15, 1936
EXHIBIT D-8

GEOLOGICAL REPORT ON
HAYCOCK HARBOR RESERVOIR SITE

PASSAMAQUODDY TIDAL POWER PROJECT
GEOLOGICAL REPORT ON THE HAYCOCK HARBOR
STORAGE RESERVOIR

BY IRVING B. CROSBY
CONSULTING GEOLOGIST

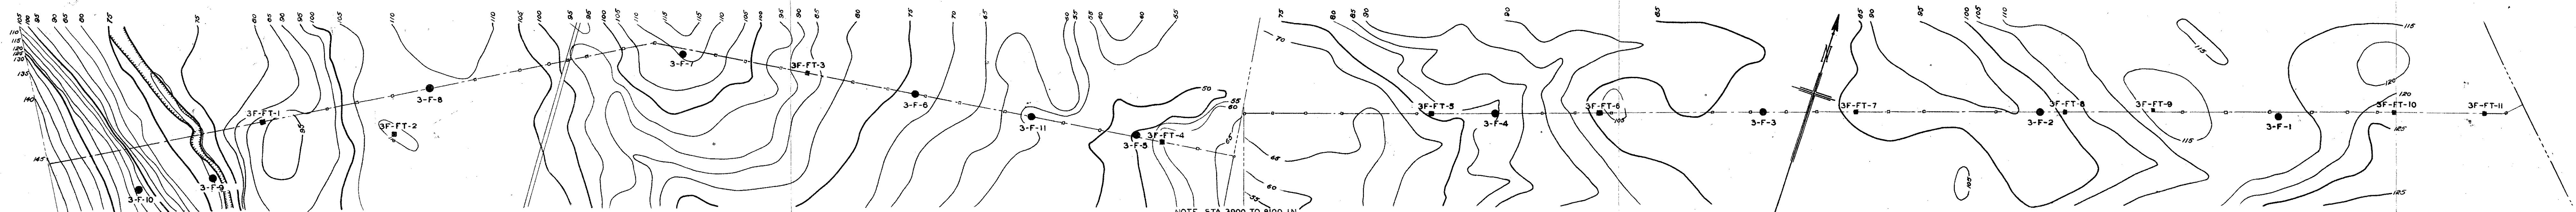
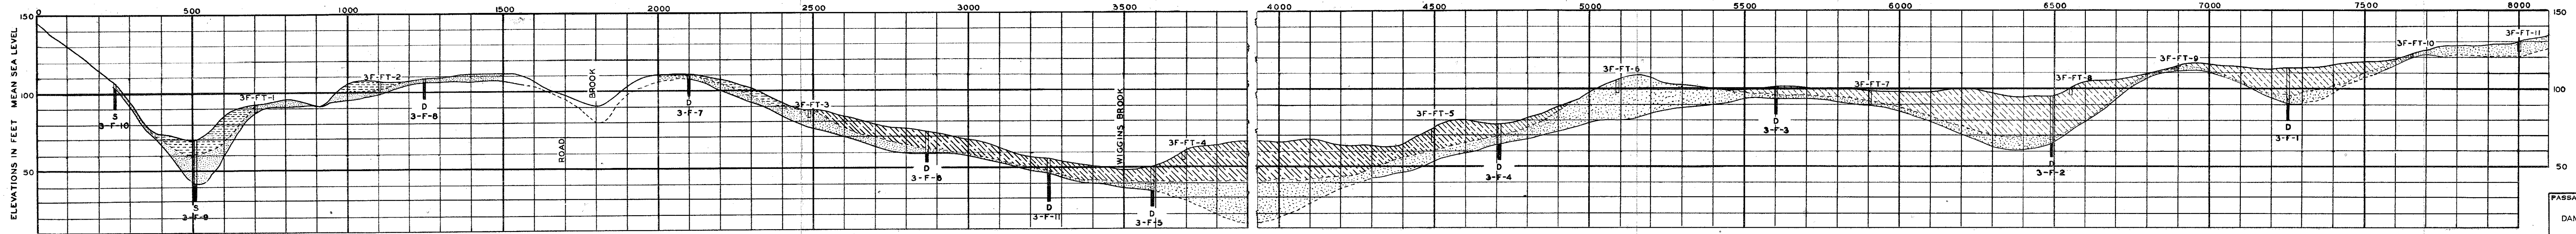
The first part of this dam site crosses a brook valley from a hillside in which rock is encountered near the surface, by boring 3-F-10, to a hillside in which test pit 3-F-F1-1 exposed bed rock at a depth of four feet. Boring 3-F-9 by the small brook encountered bed rock at a depth of twenty-nine feet indicating a buried bed rock valley beneath the brook. It appears probable that this boring is near the deepest part of the buried valley. Boring 3-F-8 on the plateau encountered bed rock at a depth of two feet. On the plateau between pit 3-F-F1-1 and boring 3-F-8, overburden is probably thin everywhere, the greatest probable depth being 10 to 15 feet. Part of the overburden is sandy and part of it is silty, but its character is unimportant on account of its thinness. It would provide stable foundations for an earth dam, and if further investigations by test pits should indicate pervious conditions a cut-off to bed rock would be a simple matter.

Under the brook, however, conditions are different. The boring here indicated ten feet of silt, underlain by 19 feet of gravelly sand. This lower layer is very pervious and would allow considerable seepage if it were not effectively blanketed by the silt. If this blanket is continuous, seepage would be greatly reduced; therefore, if any further investigation is made of this dam site the continuity of the silt blanket and especially the conditions on the two sides of the brook valley should be carefully investigated.

The central part of this site extends from boring 3-F-6 on the plateau to boring 3-F-3 on the ridge northeast of Wiggins Stream. The western part of this section of the dam site is on the plateau and crosses a depression in which there is a small brook. The depth to rock and the character of the overburden in the vicinity of this brook is unknown, and further investigation would be needed. On the eastern part of the plateau at boring 3-F-7, the overburden is only four feet thick and is, therefore, of little importance. From this boring the dam line descends the gentle slope to the valley. The depth of overburden here is only moderate with a probable maximum of thirty feet. The lower part of the overburden is sandy and pervious but this is overlain by a silty layer. The continuity of this silt layer should be thoroughly investigated if this site is to be used.

Boring 3-F-6, near Wiggins Stream, encountered bed rock at an elevation of 35 feet or 14 feet below the surface. Although rock here is at a lower elevation than at any of the other borings, it is probable that this is not in the deepest part of the bed rock valley and that rock is lower between this hole and boring 3-F-4, some 1,100 feet to the northeast. At site 1A, described in the preliminary report, a buried valley 34 feet below sea level was found by the drill. This valley continues inland and is probably crossed by dam site F. Since, however, the valley is in shale at site 1A and only diabase was found at site F, it is probable that the buried valley is shallower at the latter site.

Boring 3-F-5 showed eight feet of clay overlying six feet of sand. In the deepest part of the bed rock valley, both the clay and the sand layers, are probably thicker since the surface is considerably higher and the bed rock is probably lower. The thick blanket of clay would effectively reduce the possibility of seepage through the sand, but a study of the settlement of the clay would be necessary. This section of the site may be considered as ending at boring 3-F-3 on the ridge east of Wiggins Stream. The overburden here is only nine feet thick, consisting of silty clay in the upper part, with a gravelly layer at the base. On account of the thinness of the overburden here and the character of the upper part there is no seepage problem, but between boring 3-F-4 and boring 3-F-5 the overburden is thicker and Pit 3-F-PT-6 indicates that it is sand and that there is no blanket of silt. The absence of a silt blanket here would permit seepage to enter the sand, and concentration of flow through this part of the overburden might cause piping. This part of the site should, therefore, receive very careful study if a dam is built here. Since, however, the depth of bed rock is not very great, probably not anywhere over thirty feet and possibly much less, it would not be difficult to prevent seepage, by a cut-off to bed rock or by other treatment.

The third section of the dam site may be considered as extending from boring 3-F-3 along the ridge to the eastern end of the site. This ridge consists of varying thicknesses of overburden on a bed rock ridge in which there are at least two saddles.

The available information indicates that this is a feasible and fairly satisfactory dam site and that there is no serious seepage problem, but a careful study of the continuity of the silt blanket would be necessary and it may be desirable to artificially extend this blanket. Present indications are that the seepage under this dam may be in the order of one-half cubic foot per second. There is probably no serious settlement problem here, but the conditions in the vicinity of Wiggins Stream and possibly at two other places, would require further investigation.

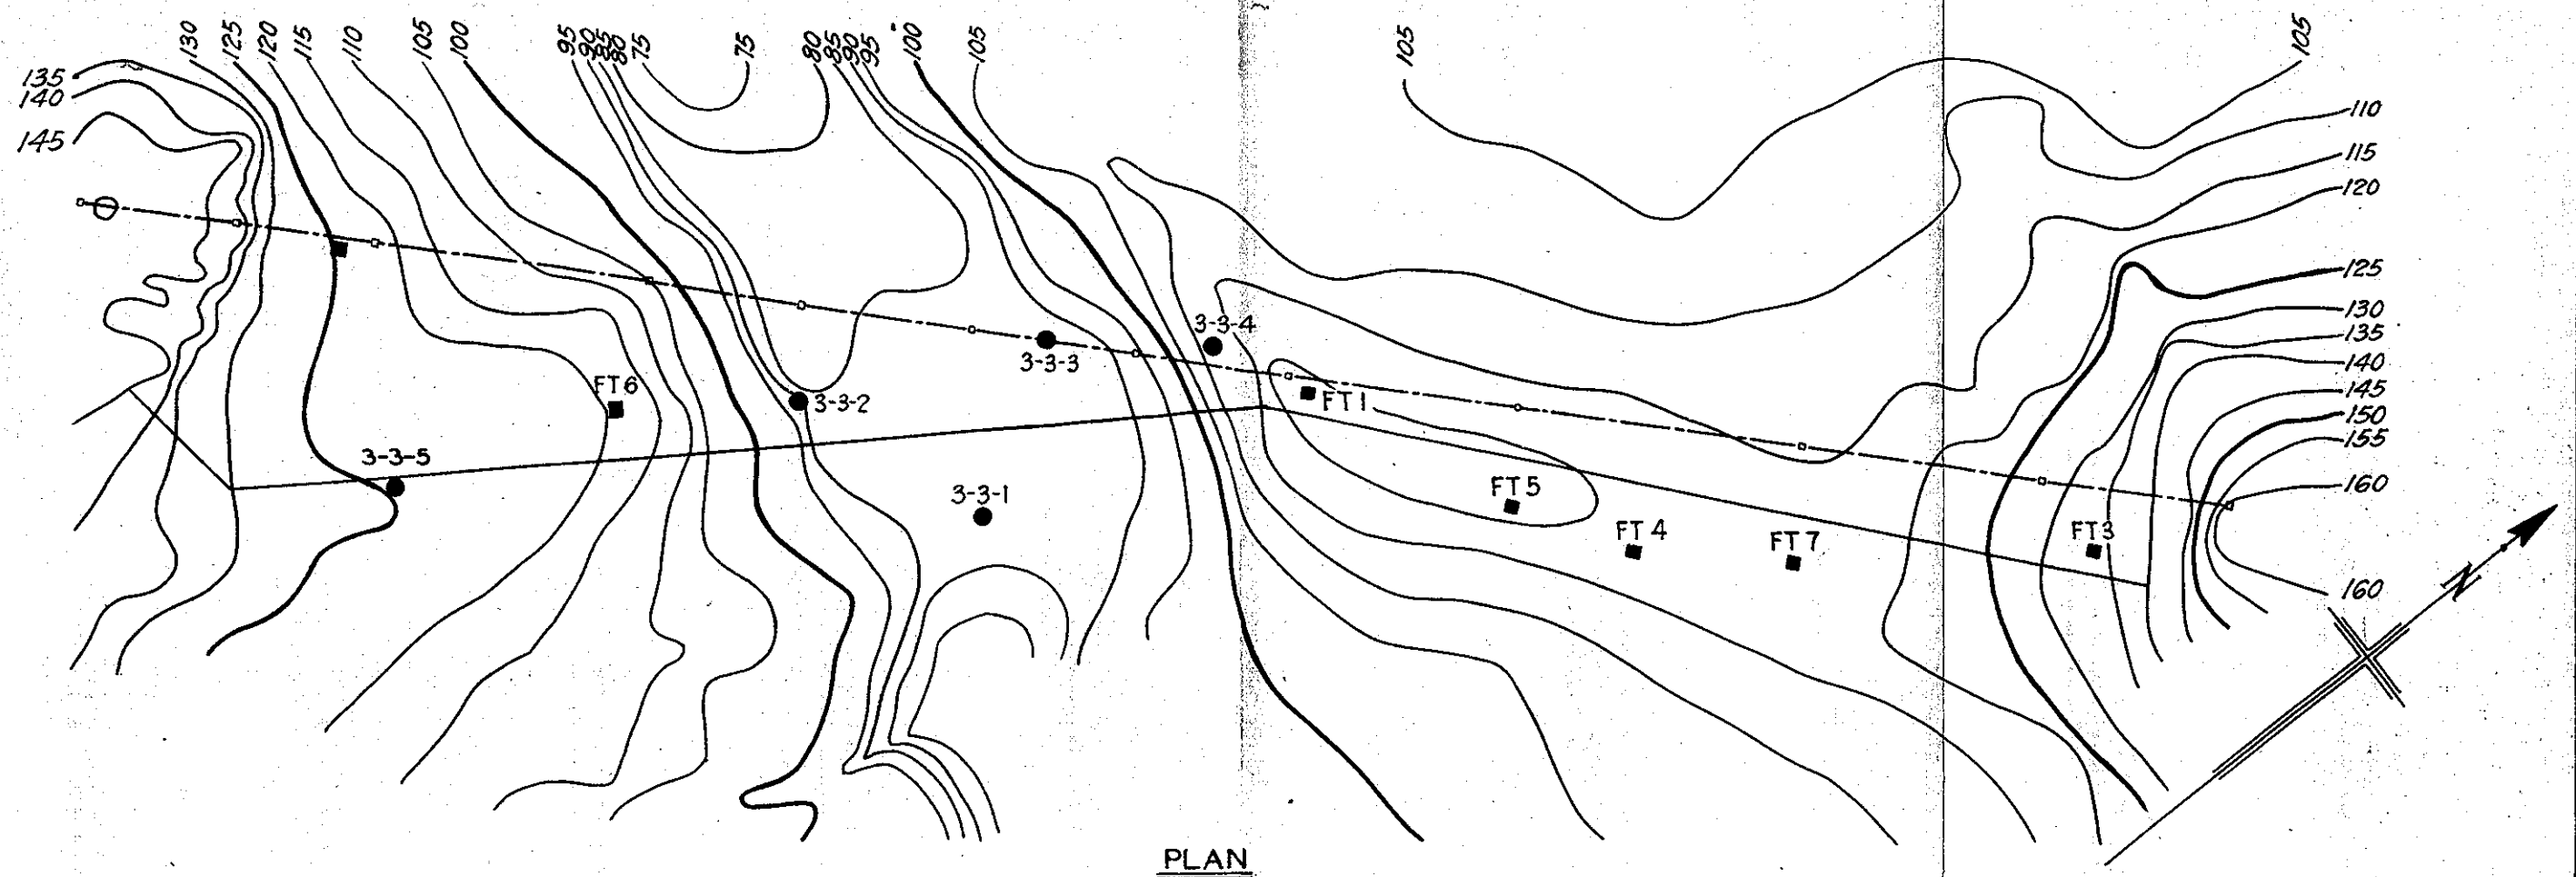
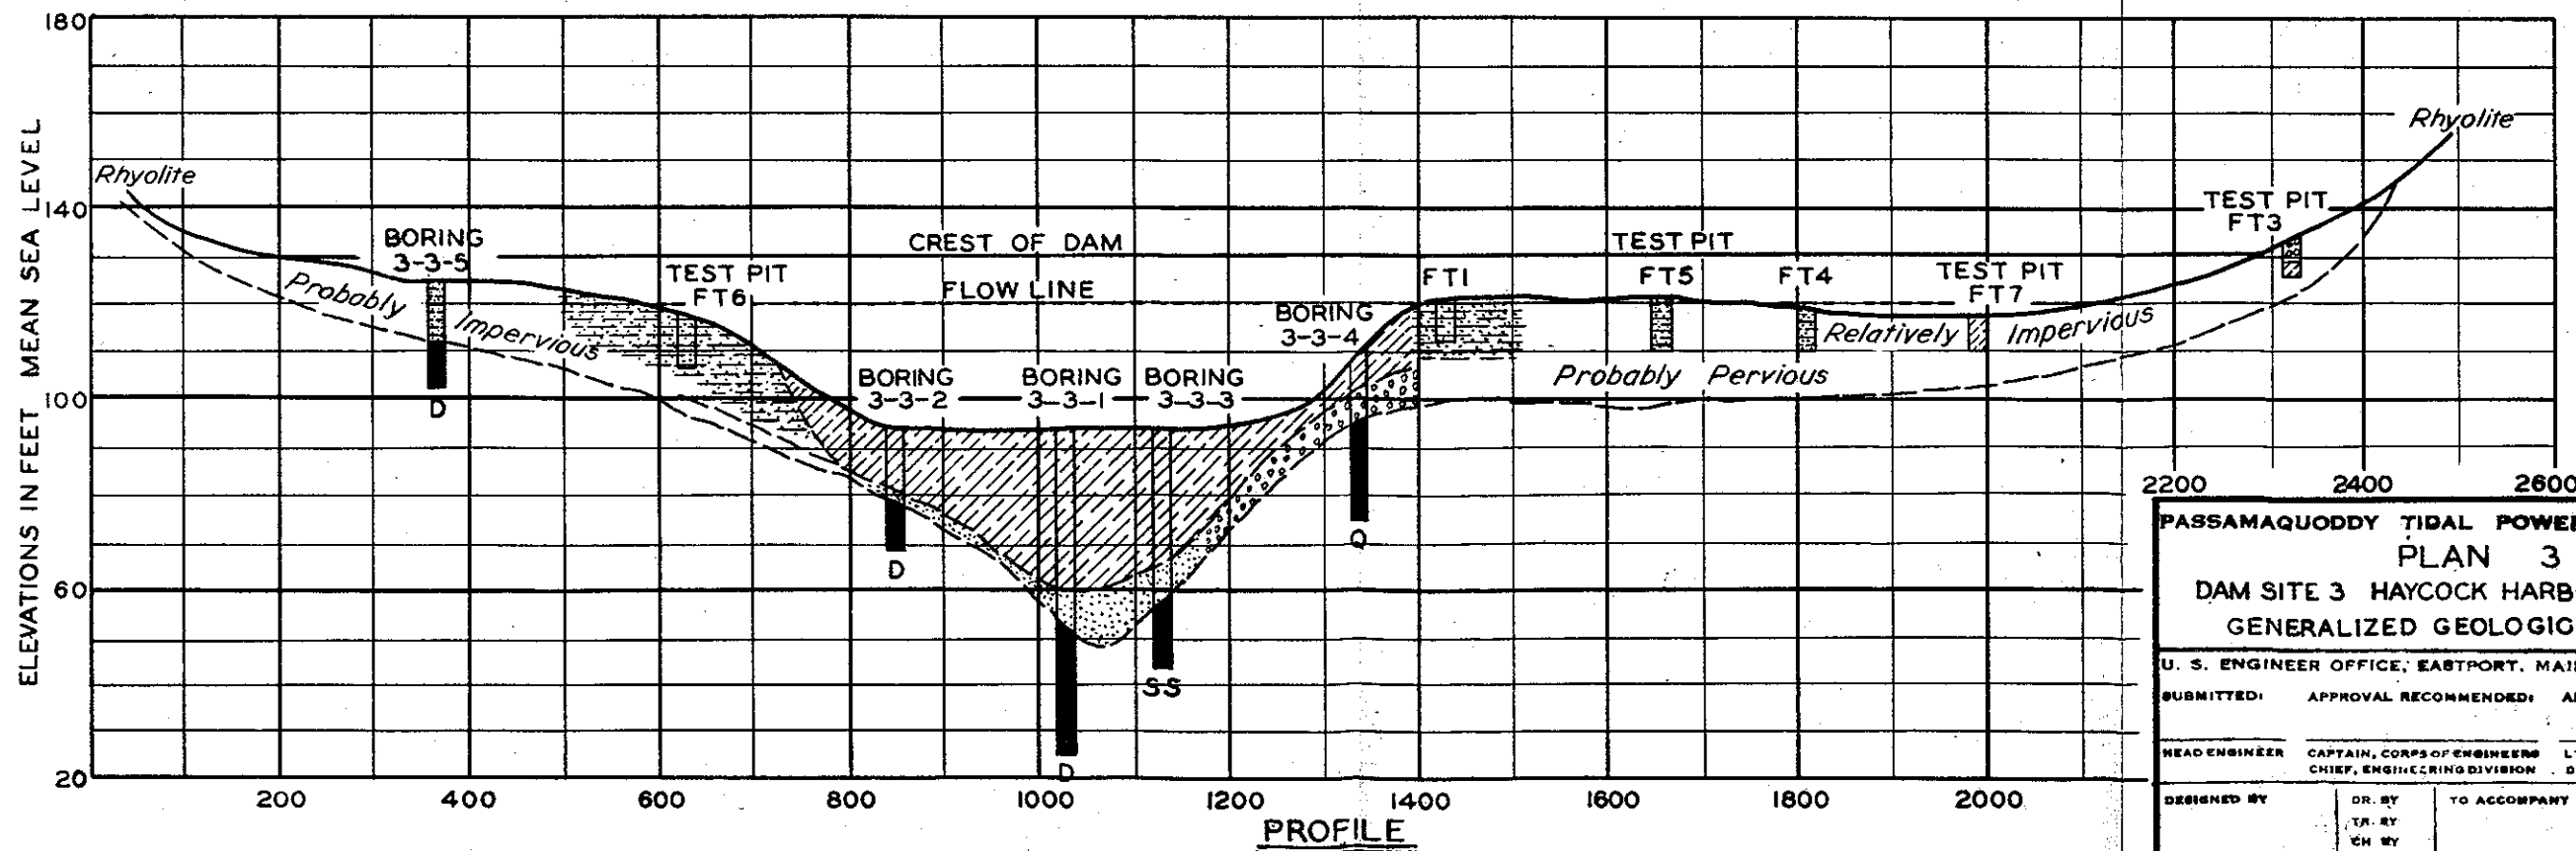
The two problems requiring attention are seepage through sand and gravel under the dam and settlement of structures founded upon clay. For convenience in study of these problems the site may be divided advantageously into three parts: 1- The long flat topped ridge at the northeastern end of the site, 2- the saddle in the south-central part of the site, and 3- the hillside at the southwestern end of the dam site.

Three borings were made in the boggy saddle between the ridge and the hill at the southwestern end of the site. Each of these borings penetrated a layer of silt and clay under which is a bed of sand and gravel. The clay layer is a very effective impervious blanket which is probably continuous for some distance but the conditions at the edges of the saddle should be investigated. It is improbable, however, that there would be any seepage problem on this part of the site. At these three holes the clay or silt are overlain by 4 to 8 feet of peaty material which it would be necessary to remove. Boring 3-3-1 penetrated 26 feet of silty

clay and hole 3-3-3 went through 25 feet of similar material. These facts indicate that there is a settlement problem here but it is probably not serious.
